# Manhole Inspection Summary

Manhole # S07CC2005MH

**Location** Address: **5906 BERKELEY AVE**

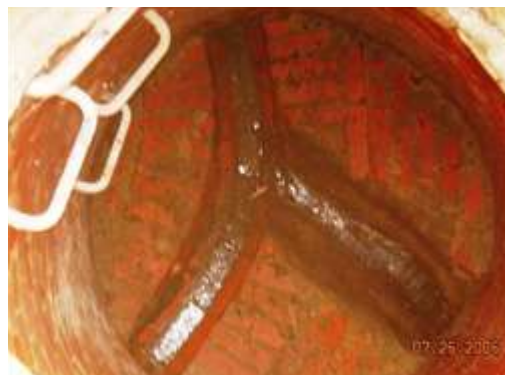
Top View

Adjustment and Barrel infiltration. Bench debris.

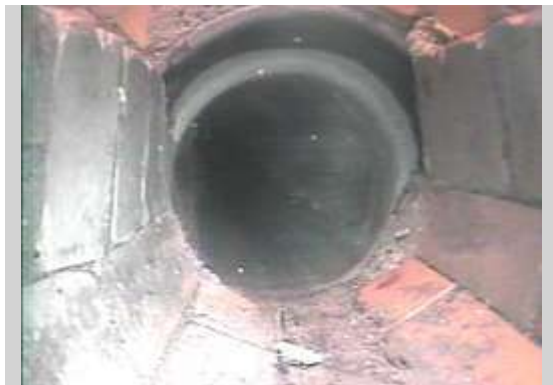
Pipe Out @ 12 O'Clock

Comments **The O12 pipe doesn't have a pipe seal. The I7 pipe seal is not flush to the pipe.**

Infiltration: **Evidence** Pipe Seal Cond: **Unknown**

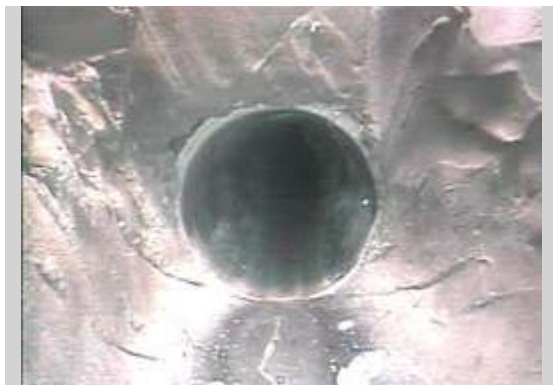
Pipe In @ 4 O'Clock

Infiltration: **None** Pipe Seal Cond: **Unknown**

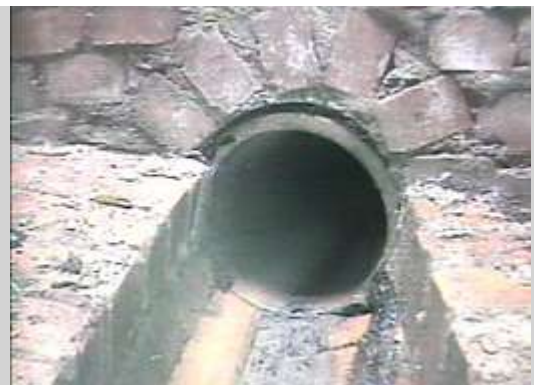
Pipe In @ 7 O'Clock

Infiltration: **Evidence**
